DEPARTMENT OF TRANSPORTATION

Quality Assurance and Source Inspection

Contract #: 04-0120F4Cty: SF/ALA Rte: 80 PM: 13.2/13.9File #: 69.28**WELDING INSPECTION REPORT****Resident Engineer:** Pursell, Gary**Address:** 333 Burma Road**City:** Oakland, CA 94607**Report No:** WIR-000375**Date Inspected:** 16-Aug-2007**Project Name:** SAS Superstructure**OSM Arrival Time:** 800**Prime Contractor:** American Bridge/Fluor Enterprises, a JV**OSM Departure Time:** 1730**Contractor:** Zhenhua Port Machinery Company, Ltd (ZPMC), Changxing Island **Location:** Shanghai, China**CWI Name:** Huang Wei**CWI Present:** Yes No**Inspected CWI report:** Yes No N/A**Rod Oven in Use:** Yes No N/A**Electrode to specification:** Yes No N/A**Weld Procedures Followed:** Yes No N/A**Qualified Welders:** Yes No N/A**Verified Joint Fit-up:** Yes No N/A**Approved Drawings:** Yes No N/A**Approved WPS:** Yes No N/A**Delayed / Cancelled:** Yes No N/A**Bridge No:** 34-0006**Component:** PQR#HP-2007 149-1**Summary of Items Observed:**

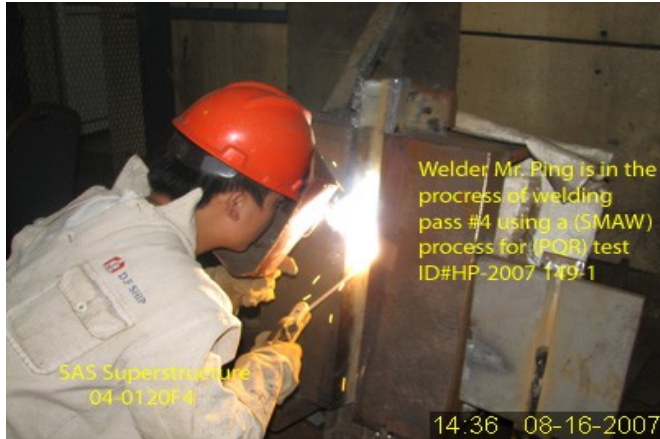
The following digital photograph illustrates Mr. Zhuhai Ping in the process of welding pass #4 using a (SMAW) process for (PQR test ID#HP-2007-149-1
